**Butler
Rowland
Mays**
Architects, LLP

Troy Public Library - *Main Branch*

Architectural Building Evaluation

Dates Performed: August 27, September 12, and October 8, 2013

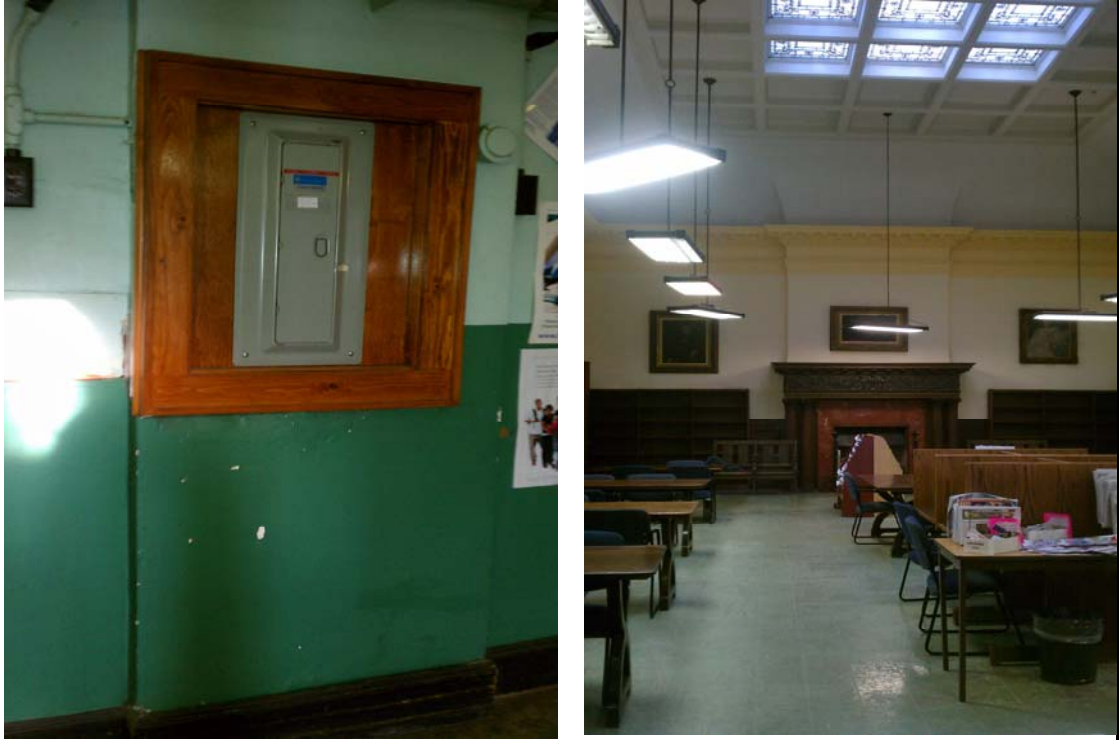
Building Element or Façade	Electrical Systems	
Photo

Existing Conditions	<ul style="list-style-type: none"> • The construction of the elevator and the associated building improvements required that a new three-phase electrical service be brought to the building. However, the electrical distribution system from the main distribution panel appears to be original, dating back to circa 1940s. This era of electrical distribution features cloth insulated wires, which is assumed to have been used in this building. • The building lacks lighting controls, most areas are controlled at the local panel boards. 	
Preliminary Recommendations CATEGORY 1	<ul style="list-style-type: none"> • The original cloth insulated wire distribution system should be removed and replaced with a new electrical distribution system meeting current code requirements. Any panels located in public areas should be secured to prevent unwanted access. • While the electrical distribution system is updated, a lighting controls package should be integrated throughout the building so that lighting controls are intuitive for staff.

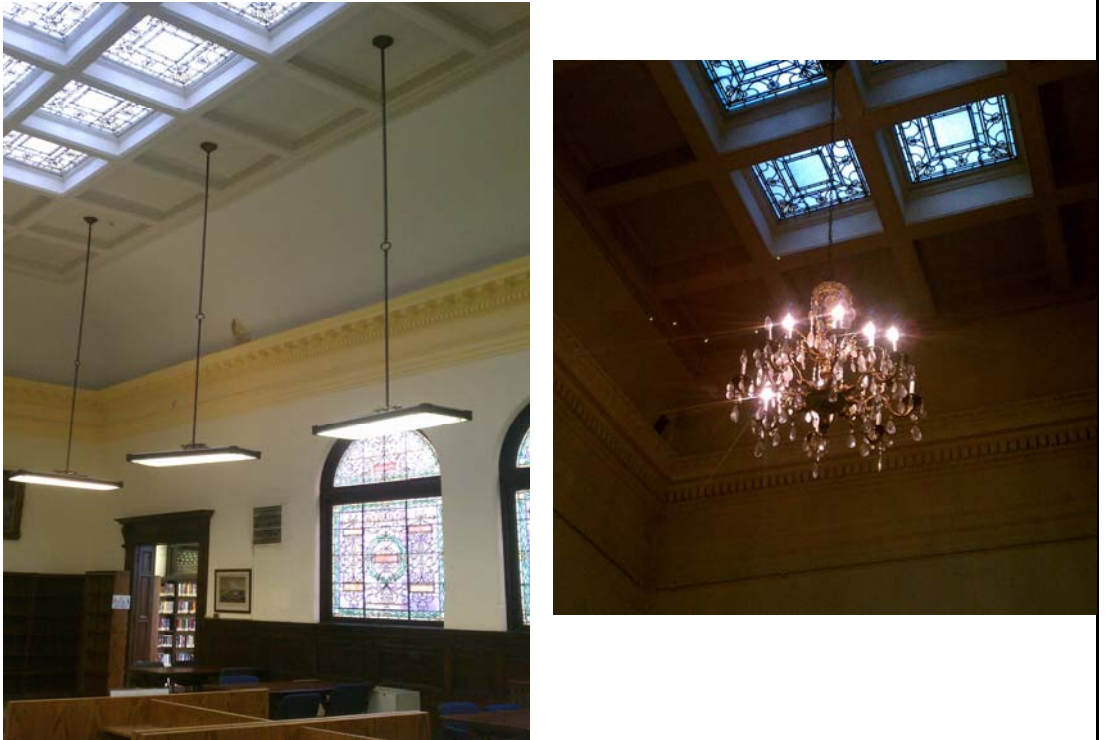
Building Element or Façade	Interior Lighting
Photo

Existing Conditions	<ul style="list-style-type: none"> • The building features a variety of lighting from historic crystal chandeliers to surface mounted and hanging florescent fixtures. Due to the various light fixtures and locations, light levels are inconsistent throughout the specific spaces, as well as the building overall.
Preliminary Recommendations CATEGORY 2	<ul style="list-style-type: none"> • Care should be taken to maintain the existing historic fixtures found throughout the building. • An energy audit should be performed to identify the amount of electricity being consumed by the florescent fixtures on the two public levels. • A comprehensive review and upgrade to the lighting fixtures is recommended to provide even light levels throughout the building.
Additional Investigation	
Notes	<p>Consideration should be given to including a daylight harvesting component to the proposed lighting controls package.</p>
